LOADBEARING MASONRY RISES HIGH IN CLEVELAND

At 17 stories, Crittenden Court Apartments becomes the tallest loadbearing masonry building in Cleveland, perhaps in the entire central United States.

New engineered brick curtain wall system eliminates need for scaffolding and shelf angles

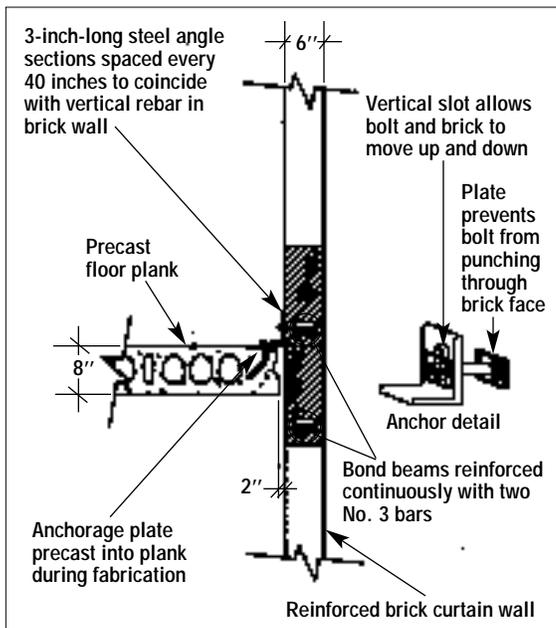
Figure 1. Attachment of 6-inch brick curtain wall to longitudinal side of precast floor planks.

For the side curtain walls (Figure 1), a standard plate was precast into the top surface of the adjacent plank every 40 inches, coinciding with the vertical rebar in the brick wall. To connect the brick to the plank, a bricklayer bolted 3-inch-long steel angles to a bond beam in the brick wall at the same 40-inch interval. Then a mason who was certified as a welder welded the horizontal legs of the angles to the plates embedded in the plank.

A vertical slot in the angles allowed the bolts (and thus the brick) to move up and down. Any lateral wind or seismic loads were transferred through the bolts to the floor. To keep the bolts from punching out through the brick face, a plate was welded to the

end of each one, and these plates were buried in the brick bond beam, confined by rebar on each side and grouted solid. This provided a positive anchor.

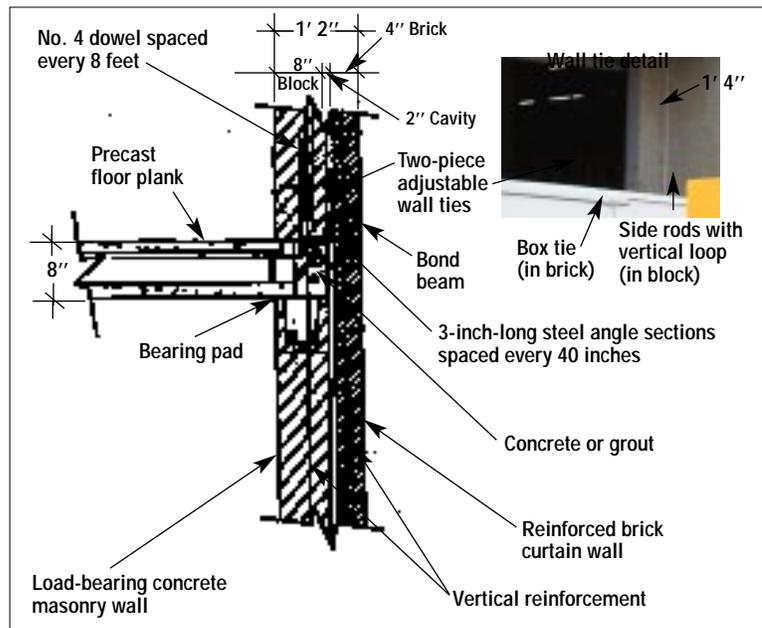
Figure 2. Attachment of 4-inch brick curtain wall to ends of precast floor planks; planks are supported by load-bearing concrete masonry walls.

The front and back curtain walls were anchored to the floors in the same way, except the anchorage plates were embedded in the ends of the planks in the field (Figure 2), not precast into the top surface of the planks during fabrication.

Because the anchorage plates were field-installed, Ebersole didn’t trust that these connections would reach full capacity. Consequently, he also had the front and back curtain walls connected by wall ties to the block backup.

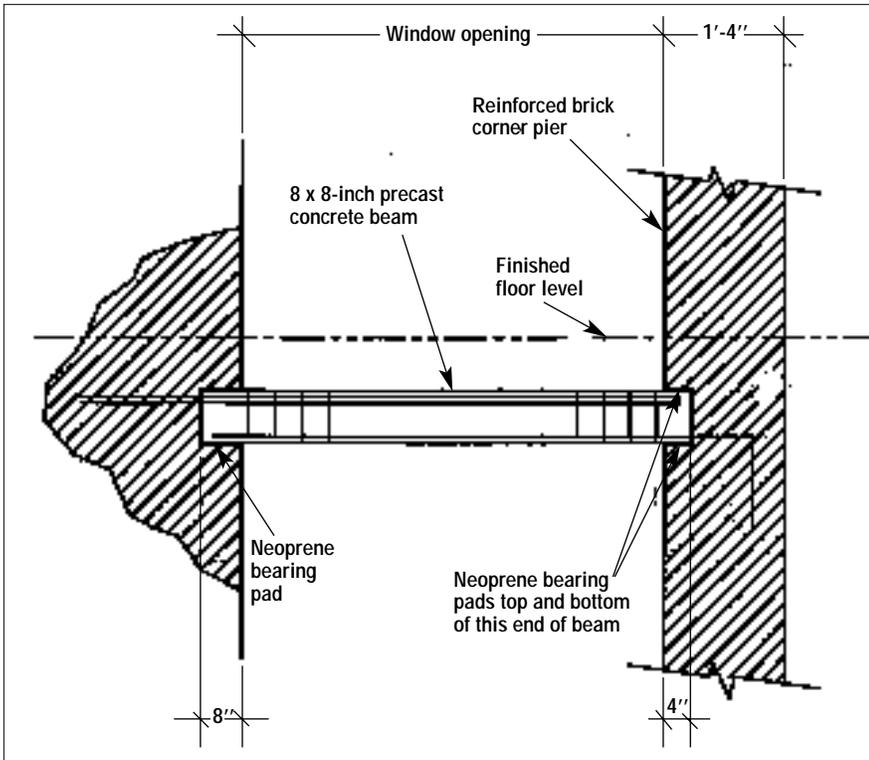
Figure 3. Precast concrete beam spans window opening between load-bearing block wall and brick corner pier.

The most challenging detail in the building was the corner pier. To maximize views, in several places the architect projected the walls enough to give the apartments two corner windows. Between these two windows was a 16x16-inch corner pier that ran the full height of the building. Here a block bearing wall met an exterior brick curtain wall. On one side of the pier, an 8x8-inch precast concrete beam spanned the opening from the pier to the block wall (Figure 3). On the other side, a brick spandrel panel in the curtain wall spanned the other opening (Figure 4).

Ebersole expected all these elements to move a bit differently. He expected the precast beam to cock some, so he had neoprene pads placed under and over the ends of it. In the brick spandrel panels, he had duct tape wrapped around the ends of the top joint reinforcement to prevent bond. The duct tape, he hoped, would let the spandrel move slightly in relation to the pier; so he had this joint caulked, except at the bottom where continuous reinforced bond beams were located. The largest crack Ebersole expected in the bottom 8 inches of mortared

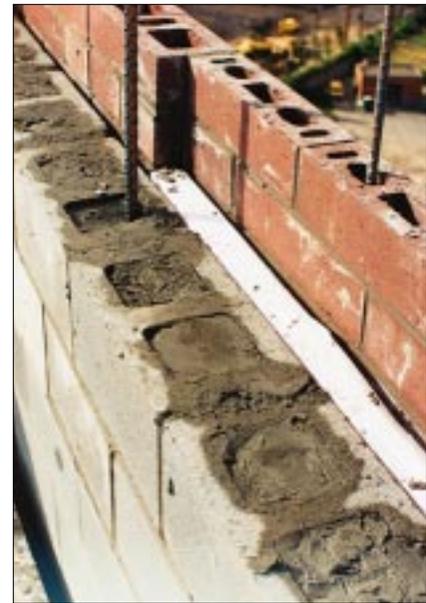
Nine parallel reinforced load-bearing concrete masonry walls support precast floor planks and carry all live loads to the foundation. Attached to every floor slab and bearing directly on the footing, reinforced brick curtain walls enclose the entire building.

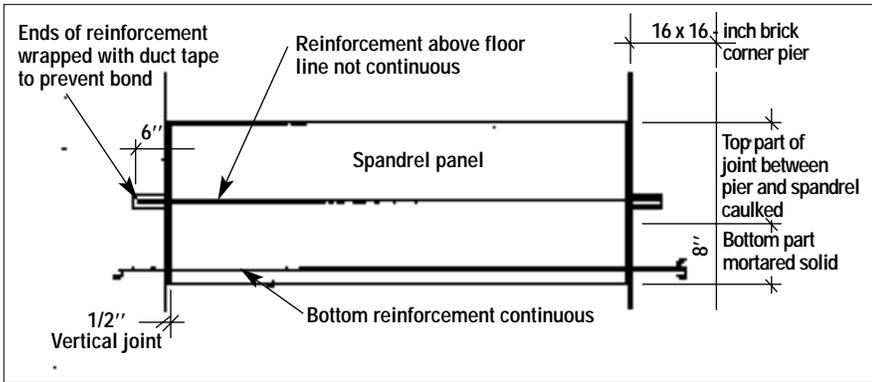
Figure 4. Reinforced brick spandrel spans window opening between brick curtain wall and brick corner pier.

joint was $\frac{1}{32}$ inch. So even if the joint cracked, it would be a tight crack. To date, no one has noticed any cracks.

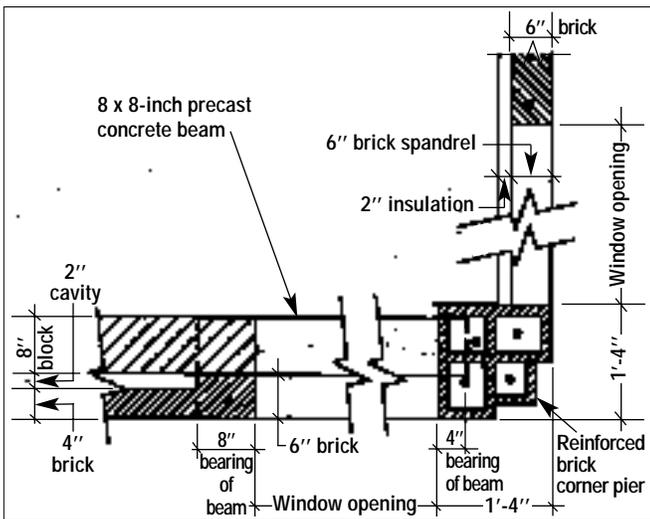
Figure 5. Reinforced and grouted, brick corner pier is made from two custom brick shapes.

The corner piers were made from special brick shapes. Early on, L.M.R. realized that building the corner piers from standard brick would require seven or eight units. This was not at all practical. So the brick manufacturer bought new forms and custom-made two special brick shapes that would produce the architect's desired notched corner detail (Figure 5).

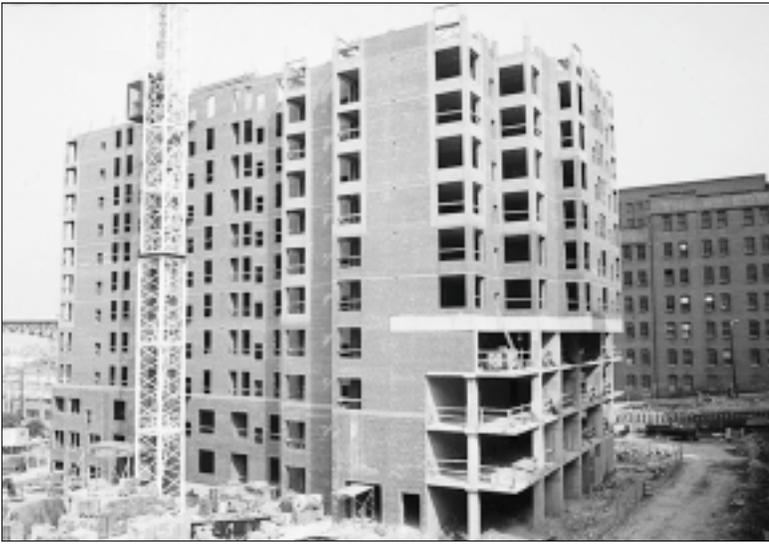
Above: The brick curtain walls were anchored at every floor to the floor planks with special anchors that allow movement vertically but not horizontally. This photo shows work up to the 10th floor, prior to construction of the garage.

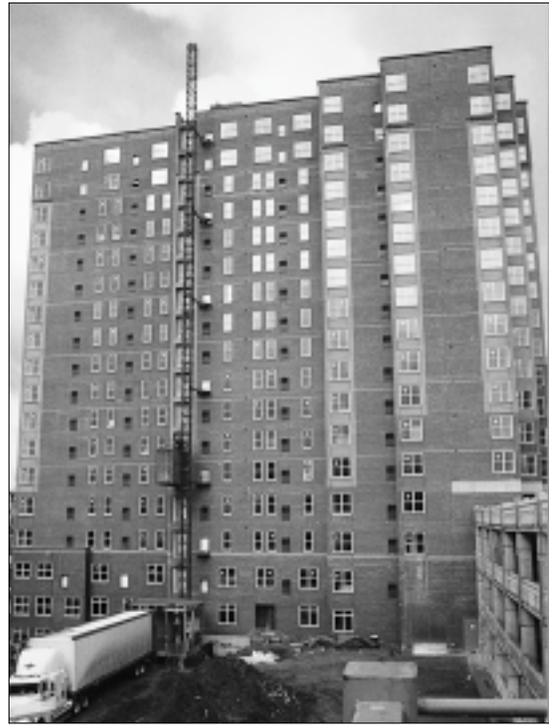
Right: Materials were moved to the interior of the topped-out building via a hoist.
